# District 40-2 Spearfish Schools

## Facilities Assessment

October 2019

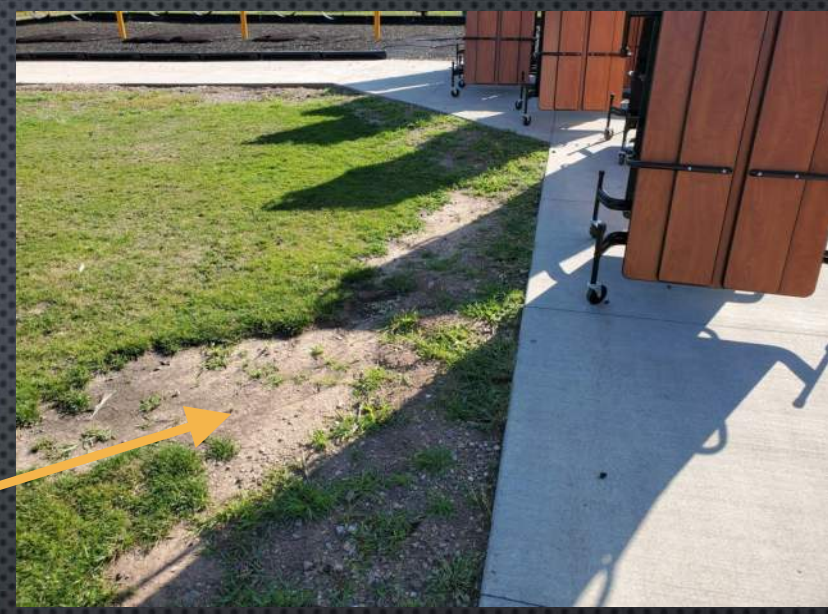
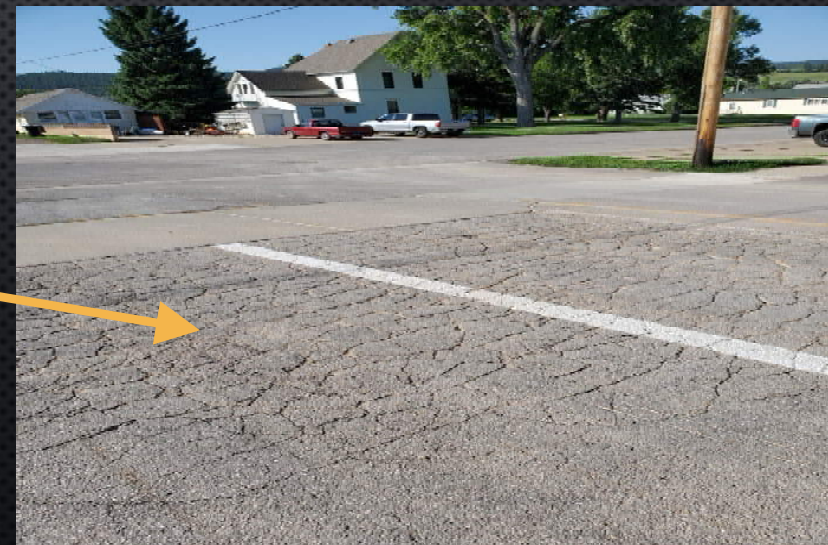
# MOUNTAIN VIEW ELEMENTARY SITE

- THERE IS EXCESSIVE WATER DRAINAGE THROUGH THE PLAY AREA
- ASPHALT HAS DETERIORATED AROUND THE SCHOOL

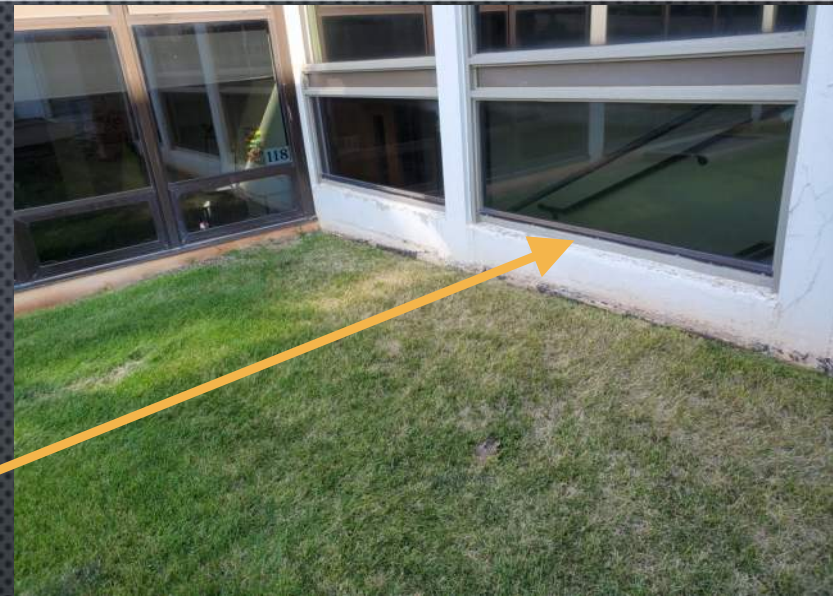
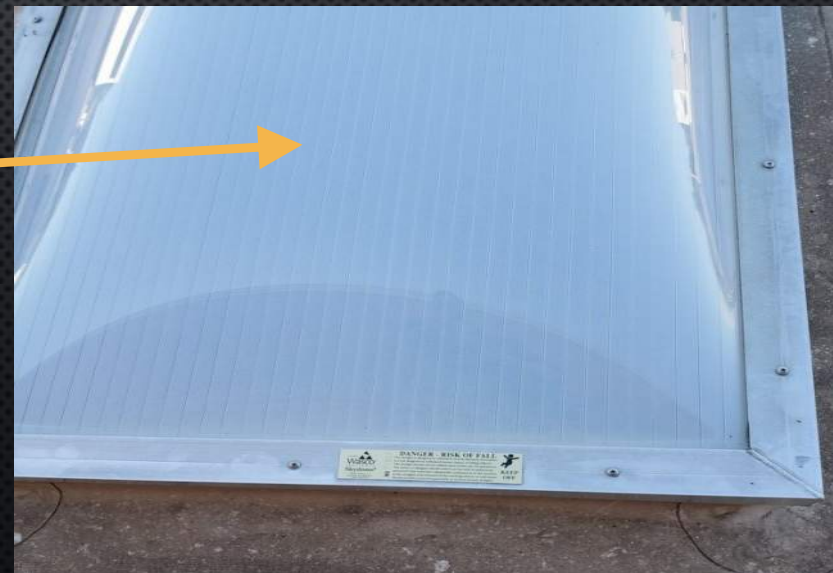
## BUILDING ENVELOPE

- WINDOWS BY ELECTRICAL ROOM SHOW SIGNS OF WATER PENETRATION
- THERE ARE NO GUARDS AROUND ANY OF THE SKYLIGHTS ON THE ROOF

Mountain View Elementary	Building Envelope - 368	Skylights	2020	\$18,700	Skylights are in good condition. There are no guards around the skylights which could pose a safety concern due to the high traffic on the roof as a result of the numerous roof top heating and cooling units, this would also protect against skylights being hidden by snow in the winter.
Mountain View Elementary	Building Envelope - 368	Secondary Structure	2020	\$4,350	There is one small plastic storage shed on site that does not meet the schools current storage needs, a larger shed (10x12) is needed.
Mountain View Elementary	Interior Surfaces - 379	Wall Paint / Paper	2020	\$795	There appears to be moisture collecting at the top of the skylights and causing the paint to peel.
Mountain View Elementary	Mechanical Systems - 380	Ventilation / Air Handling	2020	\$11,000	The building is completely served by roof top units that were installed in 2012 and are in good condition. The main electric room does not have climate control and the door is being left open to regulate the temperature inside. This is a safety issue with students having access to the space. The most cost effective solution would be to add a mini-split and electric base board heat.

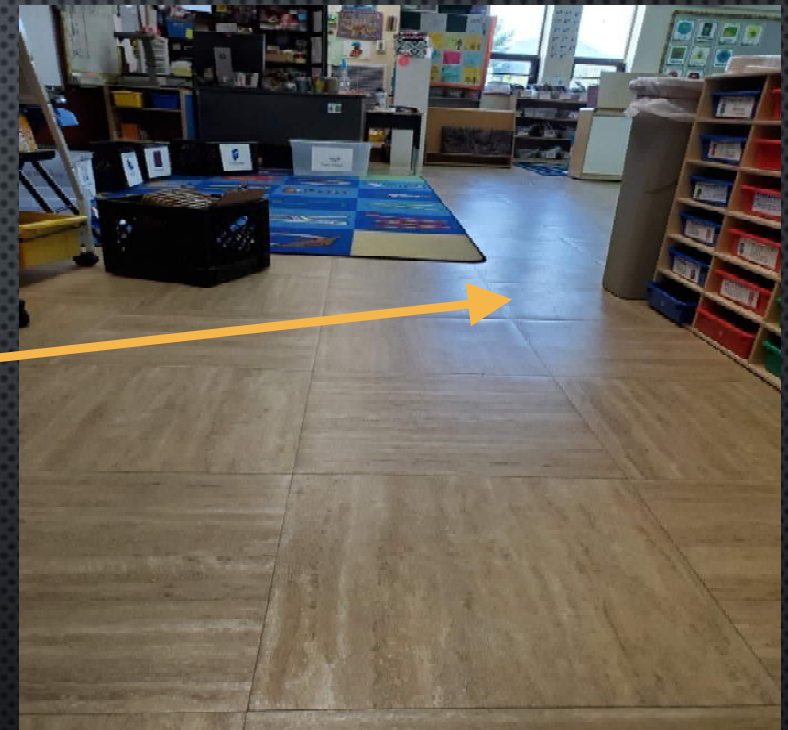
## INTERIOR FINISHES / BUILDING HARDWARE & EQUIPMENT

- LUXURY COMPOSITE TILE  
THROUGHOUT THE SCHOOL IS  
LOSING ADHESION AND  
BUBBLING

Mountain View Elementary	Professional Services and Salary - 382	Consultant	2021	\$50,185	-
Mountain View Elementary	Environmental H&S Management - 352	Management	2021	\$4,201	-
Mountain View Elementary	IAQ - 366	Commissioning	2021	\$16,802	Building is due for recommissioning in order to ensure optimal performance of HVAC systems.
Mountain View Elementary	Site Projects - 384	Parking lots / Paving	2022	\$66,217	Asphalt pavement is in poor condition with significant cracking and spalling in many sections.
Mountain View Elementary	Interior Surfaces - 379	VCT	2022	\$188,575	The LCT installed in some of the halls and classrooms is no longer adhering to the floor and there is a significant amount of bubbling occurring. This tile was installed in 2012 and it is thought that the materials used in the previous asbestos abatement process is the cause. If the PH level of the concrete is too high then Bead or Shot Blasting or grinding the surface should be done prior to new floor installation in avoid a repeat of this issue.

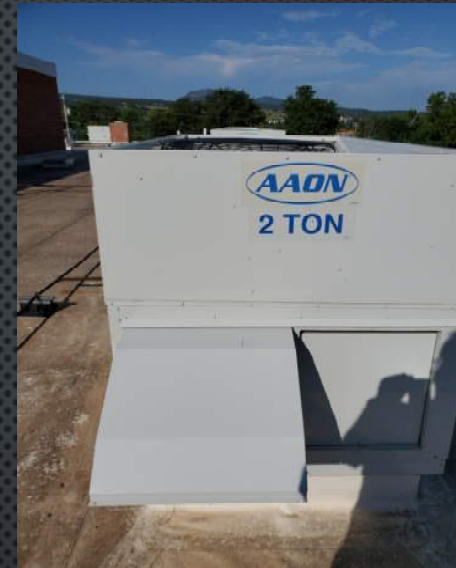
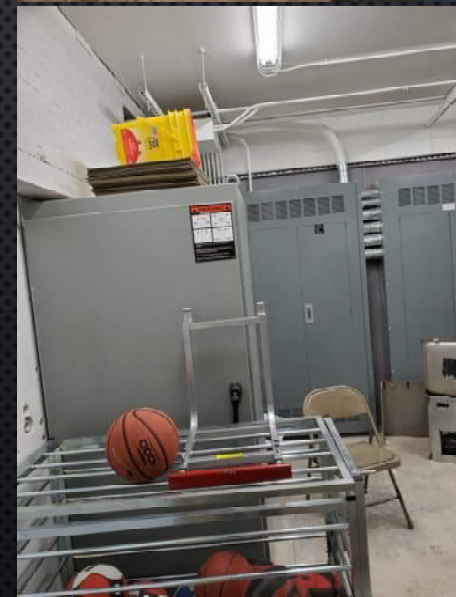
## MECHANICAL / PLUMBING

- HVAC SYSTEM IS IN GOOD CONDITION, CONTROLS ARE DUE FOR RECOMMISSIONING TO ENSURE OPTIMAL OPERATION
- NO HEATING OR COOLING IN THE ELECTRICAL ROOM, THIS RESULTS IN THE DOOR BEING LEFT OPEN

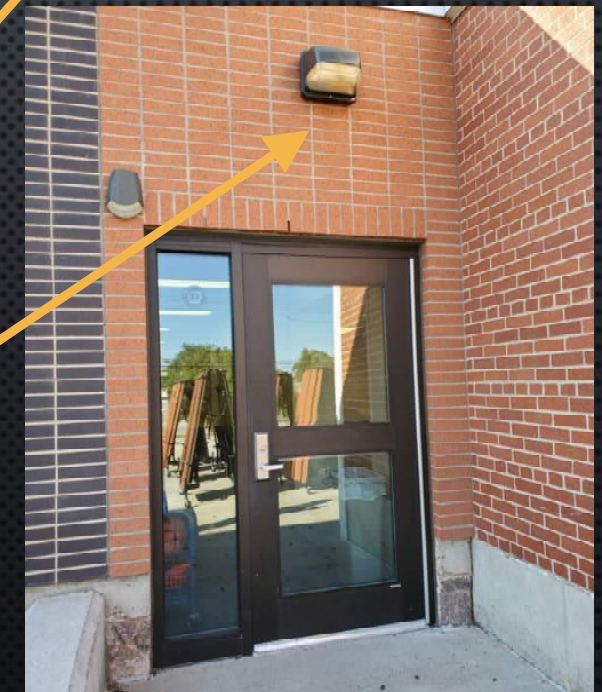
## ELECTRICAL

- FIXTURES THROUGHOUT THE SCHOOL ARE FLUORESCENT T8 TROFFERS
- THERE IS A MIXTURE OF HID AND LED WALL PACKS ON THE EXTERIOR OF THE SCHOOL

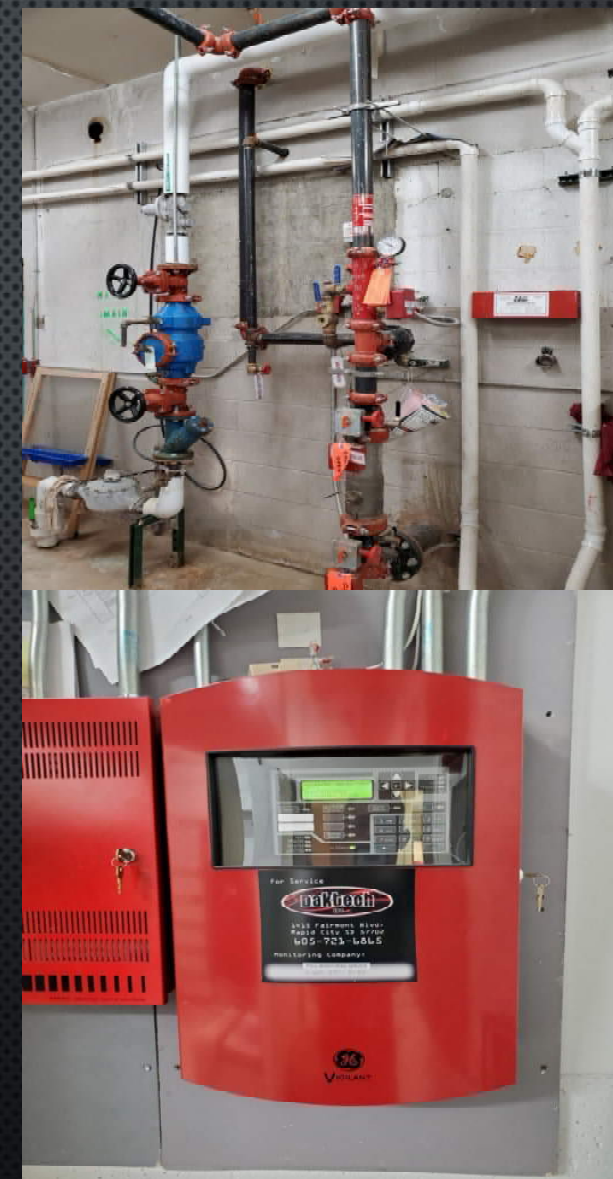
## LIFE SAFETY SYSTEMS

- ALL LIFE SAFETY SYSTEMS ARE IN VERY GOOD CONDITION AND PRESENT NO IMMEDIATE NEEDS

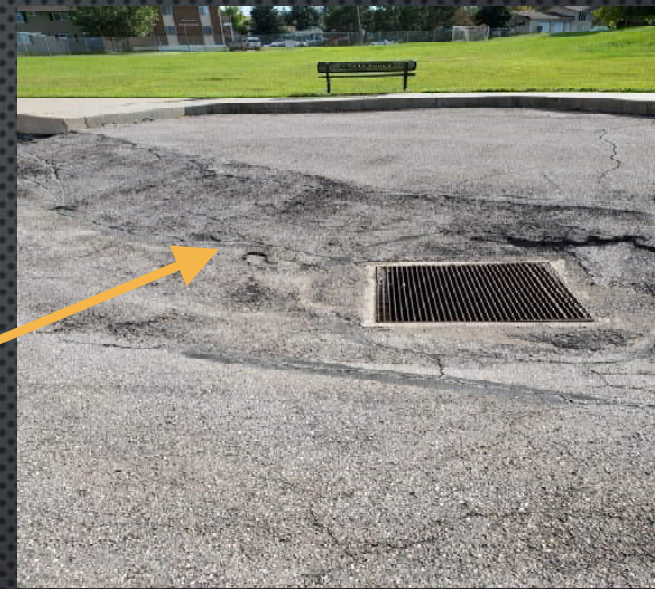
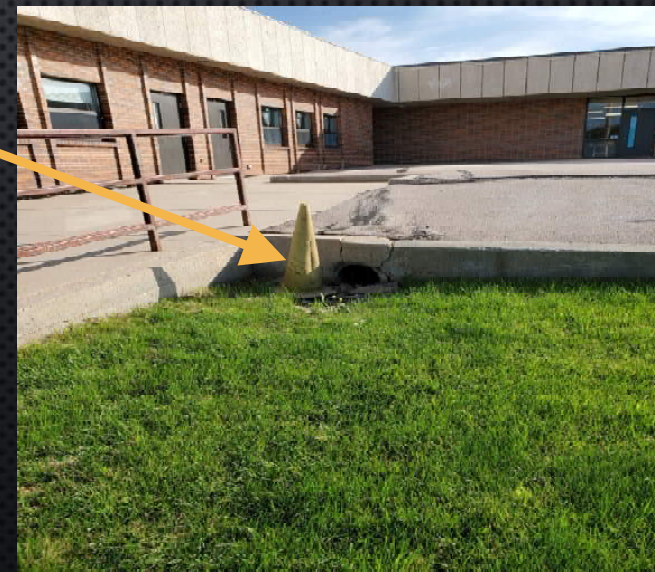
### SITE

- ASPHALT SURFACES ARE VERY DETERIORATED
- SITE DRAINAGE IS POOR ONSITE
- HIGH CONGESTION DURING DROP OFF AND PICKUP TIMES IS A SAFETY CONCERN AND A SEPARATE BUS ONLY AREA IS NEEDED

School	Category	Item Description	Year	Budget	Description
West Elementary	Site Projects - 384	Parking lots / Paving	2020	\$486,082	Parking lots are in poor condition and will need to be resurfaced. Blacktop around the school is in very poor condition, it is heaving and cracking as well as pulling away from the school. Areas around drains are particularly problematic. There has been extensive seam sealing in the past but this will probably not be effective any longer. New Bus drop-off is needed along W Mason St on the north side of the building. Will need to accommodate 6 buses.
West Elementary	Site Projects - 384	Concrete Walks / Drives / Cur	2020	\$2,304	There are many areas of cracking in the walks around the school, panels will need to be replaced.
West Elementary	Site Projects - 384	Storm Sewer	2020	\$400	Storm Drains look to be in fair condition, the deteriorated asphalt around them is the real problem. All the grates on the drains are in poor condition and will need replacement.

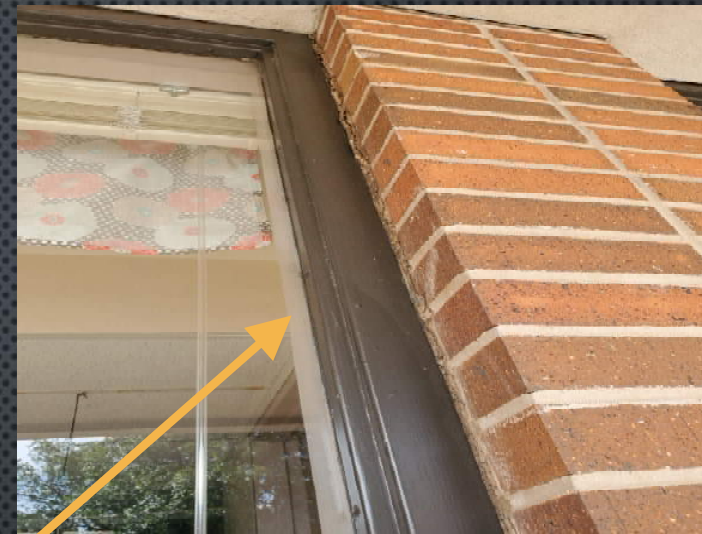
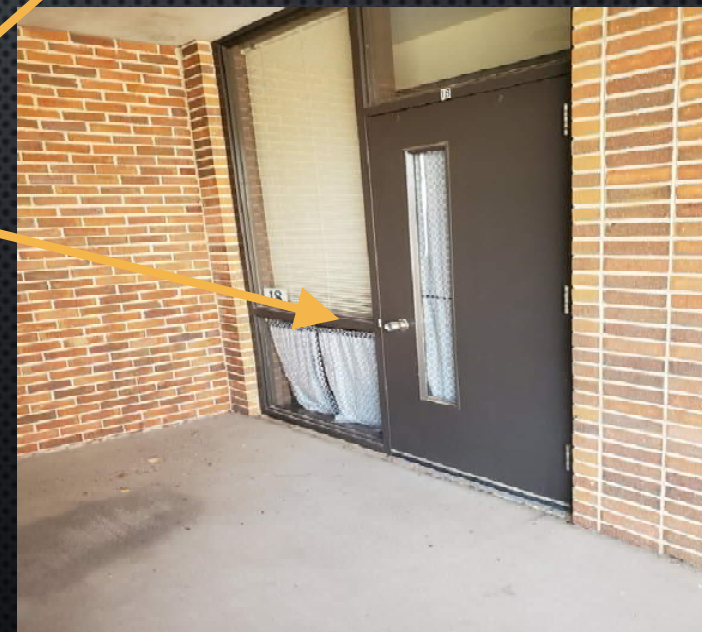
# WEST ELEMENTARY BUILDING ENVELOPE

- DOORS AND WINDOWS ON THE ORIGINAL SECTION OF THE BUILDING HAVE EXCEEDED THEIR USEFUL LIVES

West Elementary	Building Envelope - 368	Windows	2022	\$67,632	Windows in the original section of the school are single pane and have exceeded their useful life and will need to be replaced. The windows in the 1987 additions are double paned but are 32 years old and have exceeded their useful life. The windows on the administration are in good condition and present no needs.
West Elementary	Building Envelope - 368	Hollow Metal Doors / Frames	2022	\$96,542	Metal doors are same vintage as windows and have exceeded their useful life and should be replaced along with the windows.
West Elementary	Interior Surfaces - 379	VCT	2022	\$116,593	Most of the VCT in the school currently contains asbestos and will need to be replaced.
West Elementary	Interior Surfaces - 379	Classroom Casework	2022	\$273,712	Case work is dated and has exceeded its useful life, it should be replaced when floor tile is abated since it will have to be removed for the abatement process.

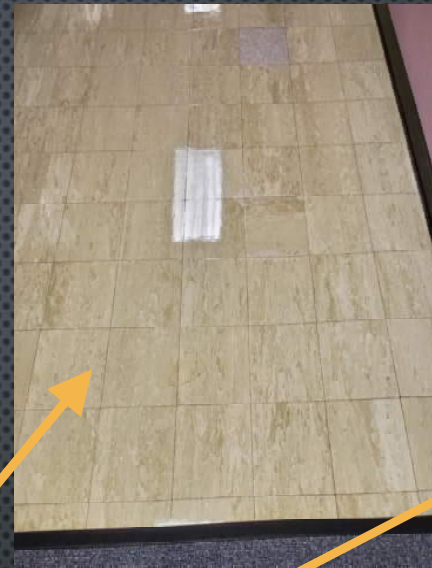
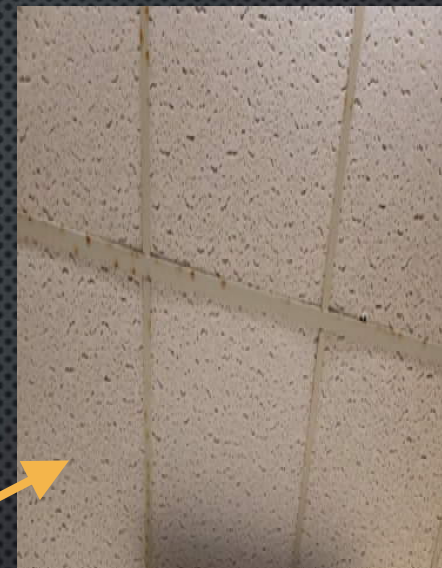
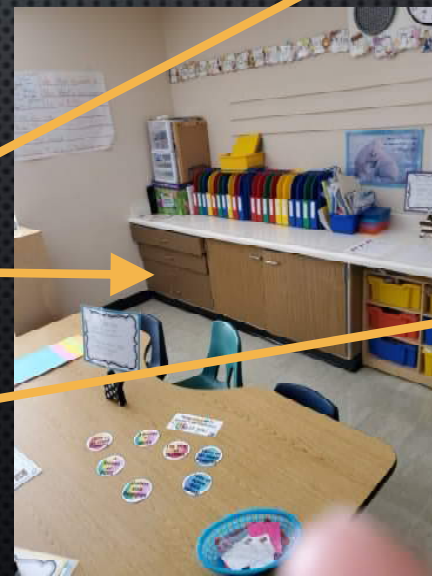
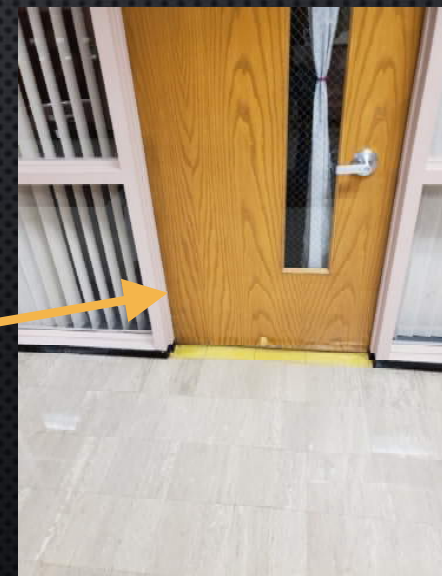
### INTERIOR FINISHES / BUILDING HARDWARE & EQUIPMENT

- ASBESTOS FLOORING IS PREVALENT THROUGHOUT THE SCHOOL
- CEILING TILE IS IN POOR CONDITION
- CASEWORK IS OUTDATED
- WOOD DOORS THROUGHOUT THE SCHOOL ARE IN POOR CONDITION

West Elementary	Professional Services and Salary - 382	Consultant	2022	\$139,681	-
West Elementary	Asbestos Removal and Encapsulation - 358	Removal / Encapsulate	2022	\$466,372	Abatement of existing asbestos positive floor tile. Care must be made to avoid using chemicals that could cause the same issues as Mountain View.
West Elementary	Environmental H&S Management - 352	Management	2022	\$116,593	-
West Elementary	Interior Surfaces - 379	Carpet	2023	\$38,983	Carpet in all areas except for the administration offices is in poor condition and will need replacement. Carpet in the administration area is in good condition and presents no immediate needs.
West Elementary	Interior Surfaces - 379	Ceramic / Proceline Tile	2023	\$16,784	Ceramic tile throughout the building varies in condition depending on location. Tile in the 2 main restrooms is dated, the grout is stained and the appearance is very dingy, it should be replaced.

West Elementary	Building Hardware & Equipment - 369	Wood Doors	2027	\$167,263	Wood doors throughout the school are in fair and poor condition and will need replacement.
West Elementary	Professional Services and Salary - 382	Consultant	2027	\$41,816	-
West Elementary	Roof Systems - 383	Roofing	2028	\$42,563	Replace section over the administration area, was last roofed in 2004.
West Elementary	Roof Systems - 383	Flashing	2028	\$4,212	Flashing is in good condition, section around administration roof will need replacement when roof is replaced.
West Elementary	Professional Services and Salary - 382	Consultant	2028	\$11,694	-

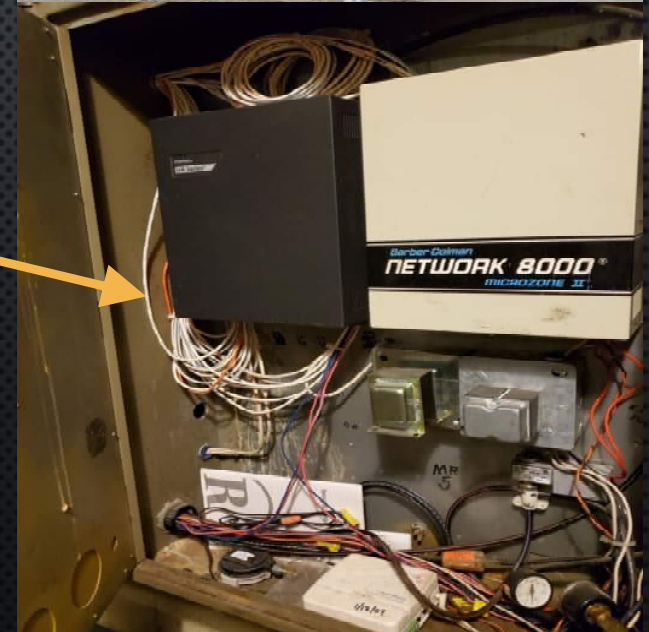
## MECHANICAL / PLUMBING

- ROOFTOP CONDENSING UNITS HAVE EXCEEDED THEIR USEFUL LIVES
- HVAC CONTROLS ARE OUTDATED AND OBSOLETE

West Elementary	Mechanical Systems - 380	Ventilation / Air Handling	2021	\$77,250	Ventilation is supplied mostly by roof top units and one air handler in the boiler room. Roof top units are within their useful lives, the air handler in the boiler room has exceeded its useful life and will need replacement.
West Elementary	Mechanical Systems - 380	Temperature Controls	2021	\$221,644	Temperature controls are mostly pneumatic and should be up dated.
West Elementary	Mechanical Systems - 380	Fire Protection System	2021	\$277,055	There is not currently a sprinkler system at the school and one should be installed.

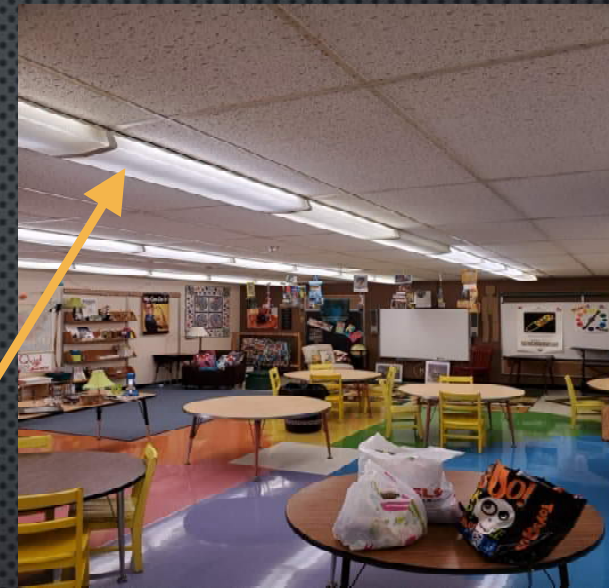
## ELECTRICAL

- LIGHTING THROUGHOUT THE SCHOOL HAS EXCEEDED IT'S USEFUL LIFE
- PANELBOARDS ARE ORIGINAL TO THE SCHOOL

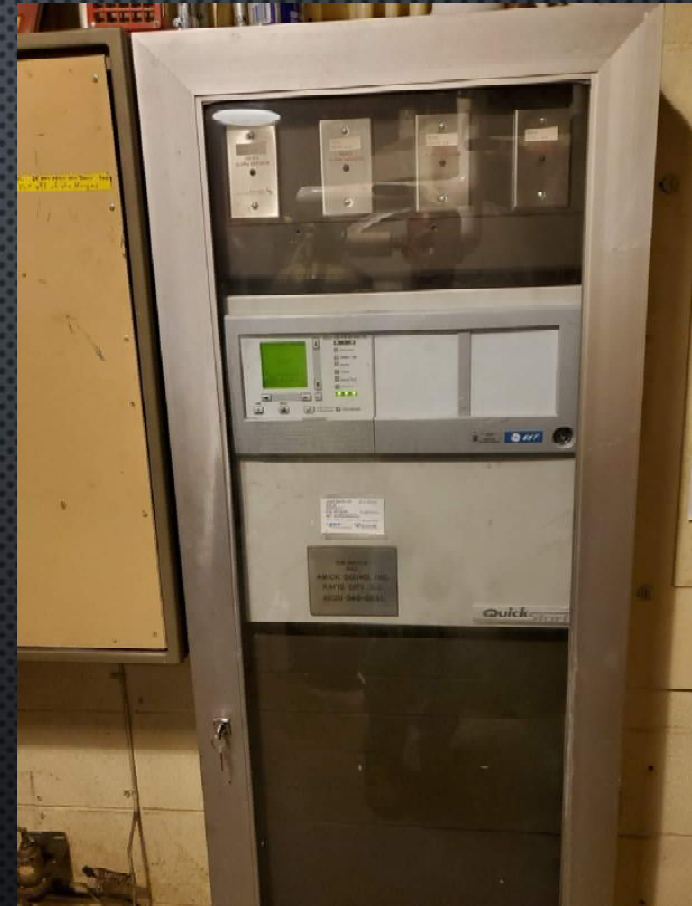
## LIFE SAFETY SYSTEMS

- FIRE ALARM SYSTEM HAS EXCEEDED IT'S USEFUL LIFE
- THE SCHOOL DOES NOT HAVE SPRINKLER FIRE PROTECTION

West Elementary	Site Projects - 384	Landscaping	2020	\$7,965	Concrete retaining walls between asphalt and grass areas are collapsing, they should be replaced along with the asphalt. These walls would more than likely be eliminated if new bus drop-off is constructed.
West Elementary	Site Projects - 384	Drainage	2020	\$2,750	Drainage looks to be effective but many of the drain lines running under the asphalt look to be in poor condition and are causing the asphalt to heave and crack. These lines will need to be replaced when the asphalt is.
West Elementary	Building Envelope - 368	Sealants	2020	\$5,000	Sealants around the building are in poor condition, they are cracking and shrinking and will need to be replaced.
West Elementary	Building Envelope - 368	Brick / Block	2020	\$4,000	There are areas at the base of the school where the brick is damaged due to being pulled away by sinking sidewalks.
West Elementary	Mechanical Systems - 380	Fire Alarm System	2020	\$43,038	The Fire Alarm system is older and non-addressable.

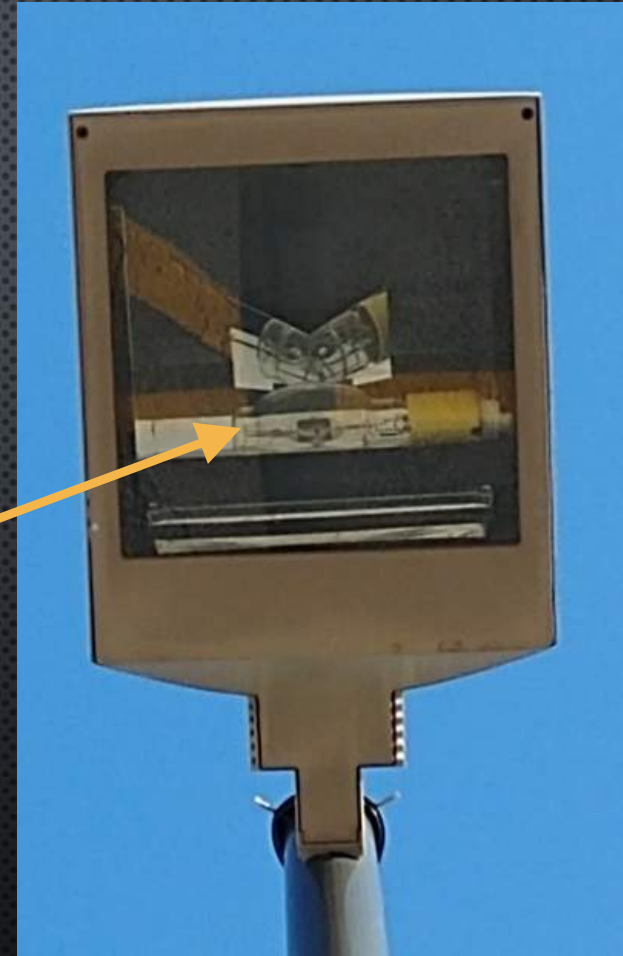
## SITE

- POLE LIGHTING CONSISTS OF HID BULBS

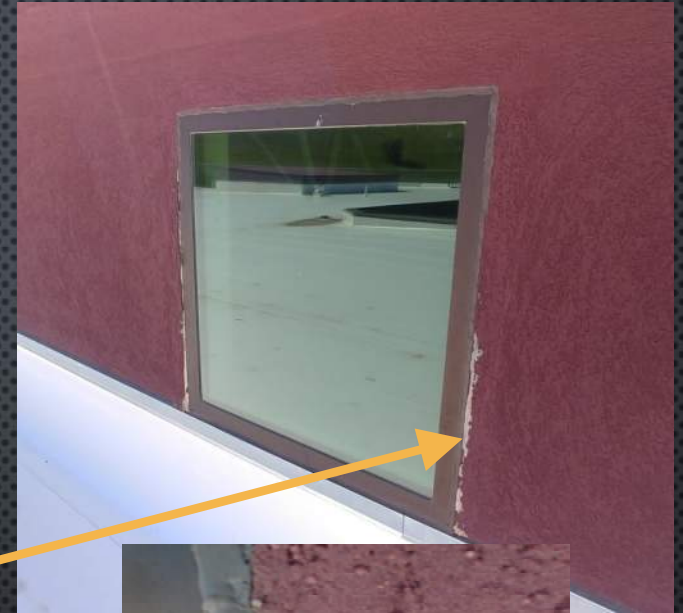
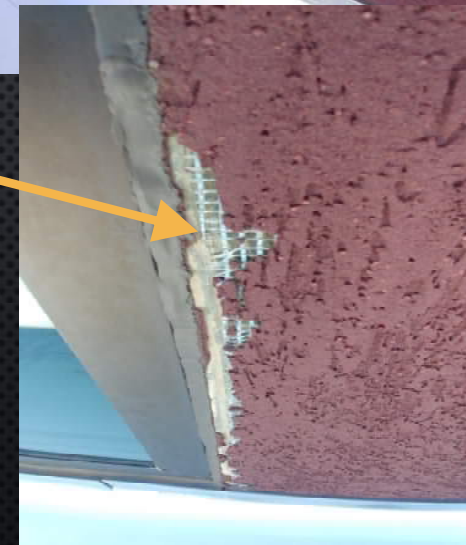
## BUILDING ENVELOPE

- MINOR MISSING EFIS MATERIAL AROUND UPPER WINDOWS

School	Category	Item Description	Year	Budget	Description
Creekside Elementary	Building Envelope - 368	EFIS / Stucco	2020	\$2,500	The EFIS walls above the roof have missing material in sections near the windows.
Creekside Elementary	Professional Services and Salary - 382	Consultant	2020	\$625	-
Creekside Elementary	Interior Surfaces - 379	Other	2021	\$1,380	The bathroom in the kitchen appears to have settled causing substantial cracking along the exterior wall. The porcelain tile that lines the wall and the concrete/epoxy flooring has significant cracking.
Creekside Elementary	Professional Services and Salary - 382	Consultant	2021	\$345	-
Creekside Elementary	Site Projects - 384	Site Lighting	2022	\$12,731	The front site (Parking Lot) lighting has 12 poles, 10 single head and 2 double head HID pole lights. The back site (Bus Loop) lighting has 10 single head HID pole lights.
Creekside Elementary	Electrical - 370	Lighting - Classrooms	2022	\$323,018	Lighting in the halls is T8 fluorescent. Fixtures are original to the building and have exceeded their useful life and should be converted to LED fixtures rather than continue to repair existing fixtures. A lighting control system should be installed along with fixtures.

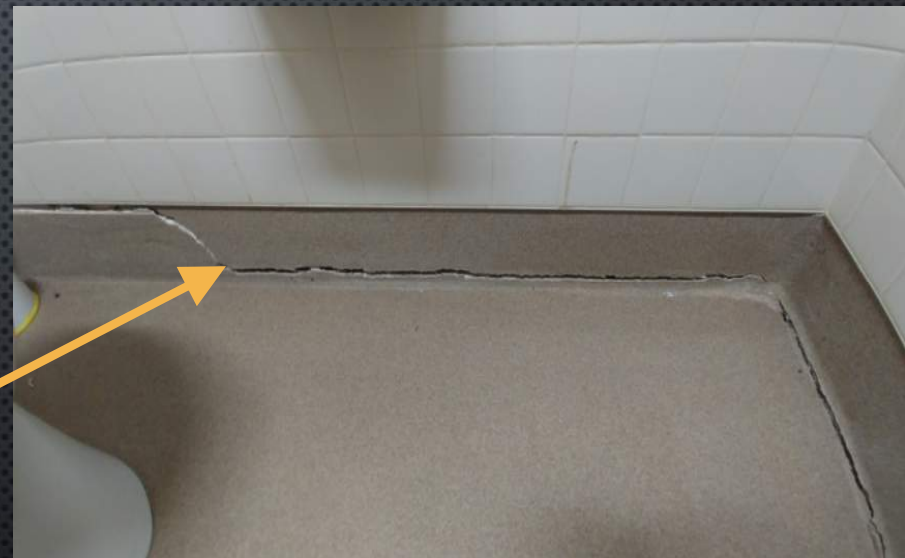
### INTERIOR FINISHES / BUILDING HARDWARE & EQUIPMENT

- CRACKING ALONG EXTERIOR  
WALL IN KITCHEN RESTROOM

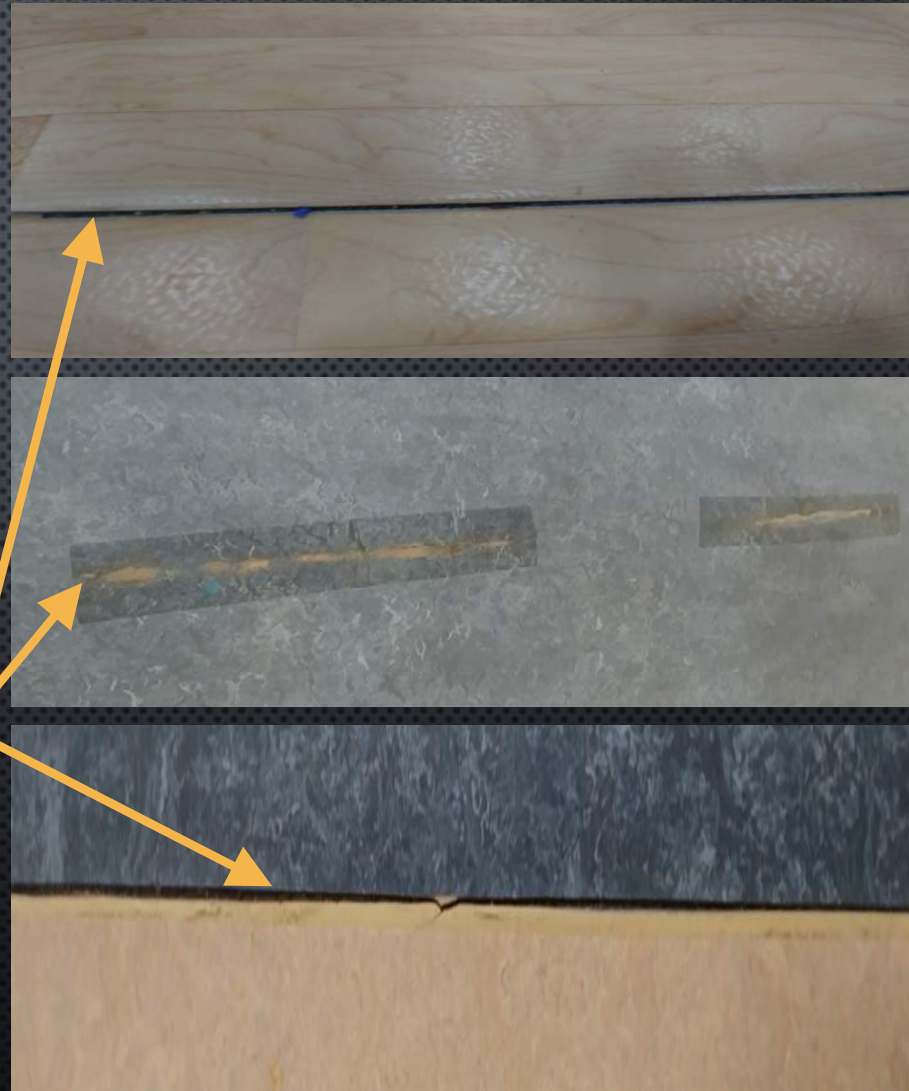
### INTERIOR FINISHES / BUILDING HARDWARE & EQUIPMENT

- MARMOLEUM SEALS ARE CRACKING AND PULLING APART. THESE CAUSE TRIPPING HAZARDS AND AREAS FOR MOISTURE TO GAIN ACCESS BEHIND THE MATERIAL.

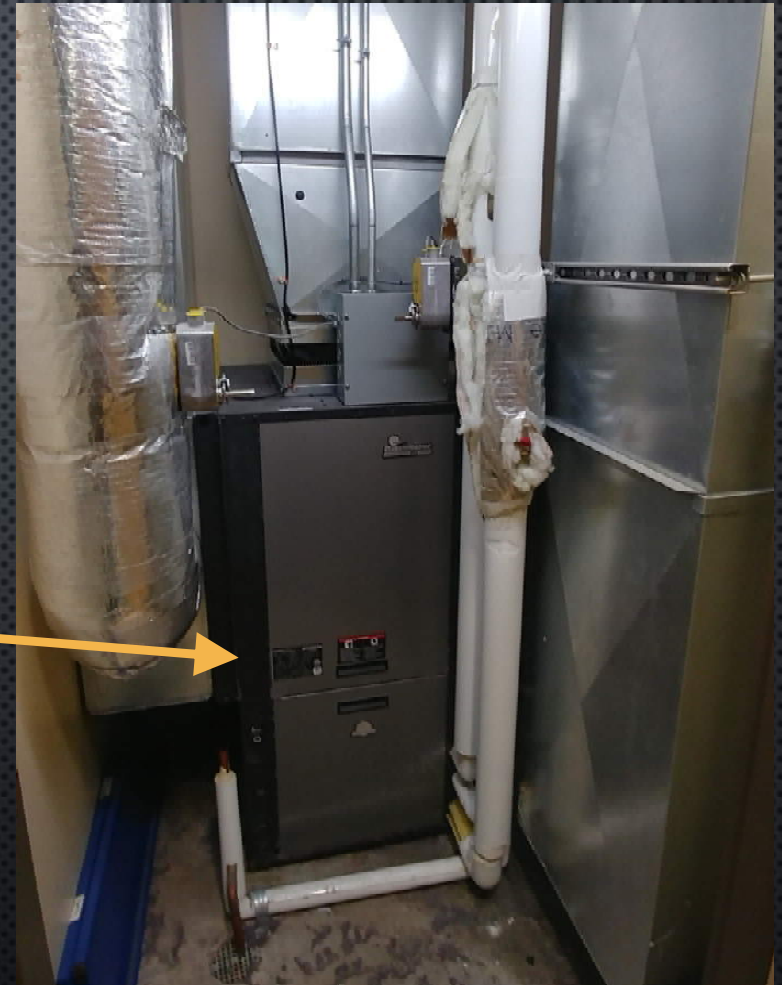
## MECHANICAL / PLUMBING

- HEAT PUMPS HAVE TROUBLE WITH MOTORS AND CIRCUIT BOARDS BURNING OUT

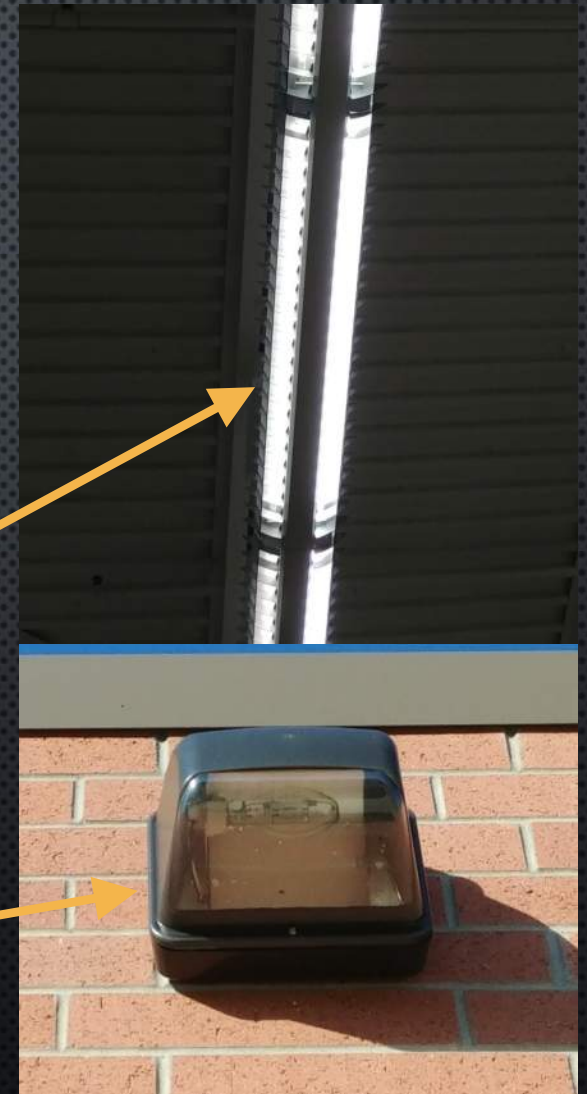
## ELECTRICAL

- BUILDING LIGHTING
  - THE INTERIOR CONSISTS OF FLUORESCENT
  - THE EXTERIOR MOSTLY CONSISTS OF HIGH INTENSITY DISCHARGE (HID)

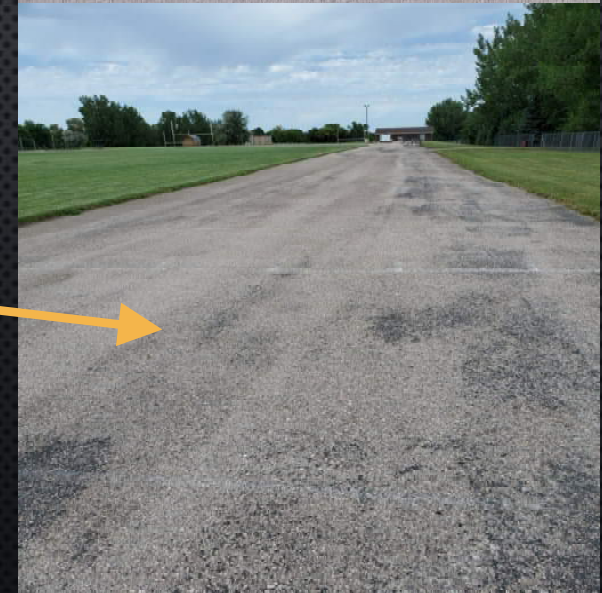
# SPEARFISH MIDDLE SCHOOL SITE

- THE DRAINAGE CANAL IS OVERGROWN AND FILLED WITH SEDIMENT
- THE RUNNING TRACK IS IN NEED OF RESURFACING

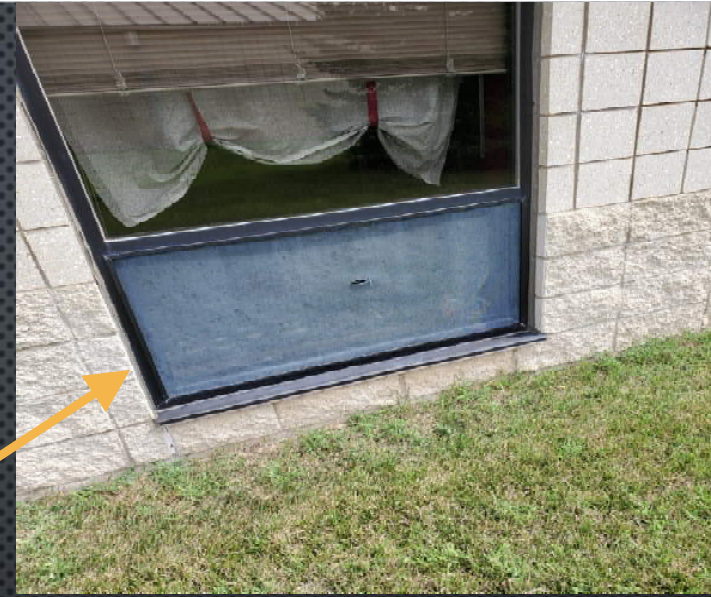
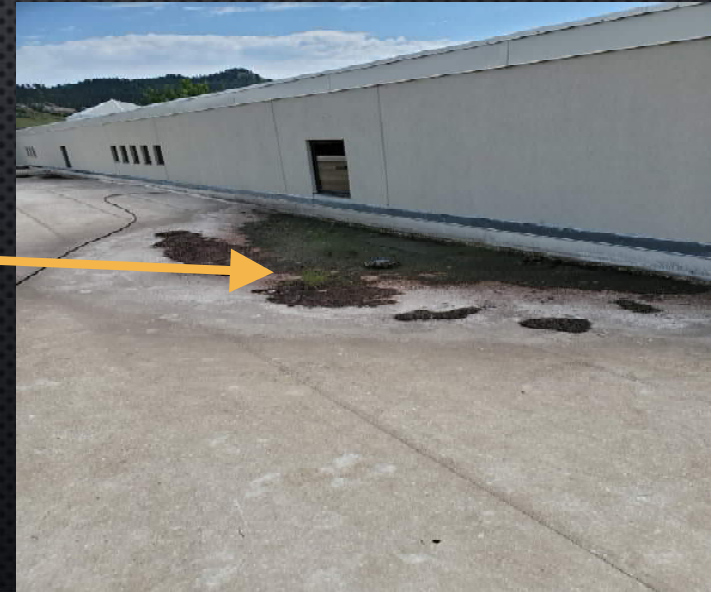
# SPEARFISH MIDDLE SCHOOL BUILDING ENVELOPE

- WINDOWS HAVE EXCEEDED THEIR USEFUL LIVES
- ROOF IS IN NEED OF YEARLY PREVENTATIVE MAINTENANCE

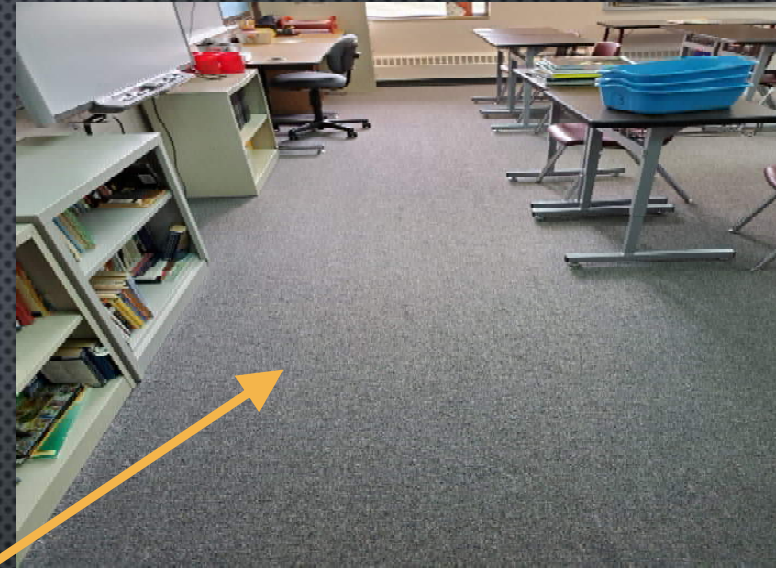
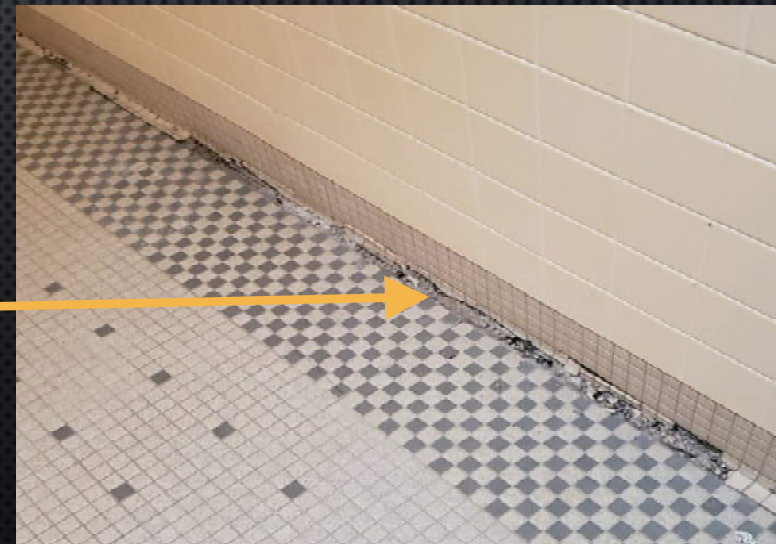
### INTERIOR FINISHES / BUILDING HARDWARE & EQUIPMENT

- CLASSROOM CARPETING IS SHOWING SIGNIFICANT WEAR
- TILE IN BOTH SHOWERS HAS EXTENSIVE DAMAGE

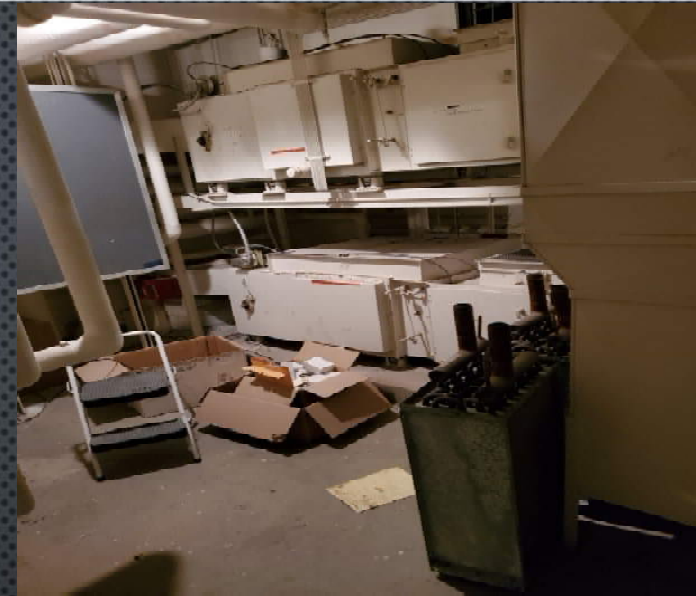
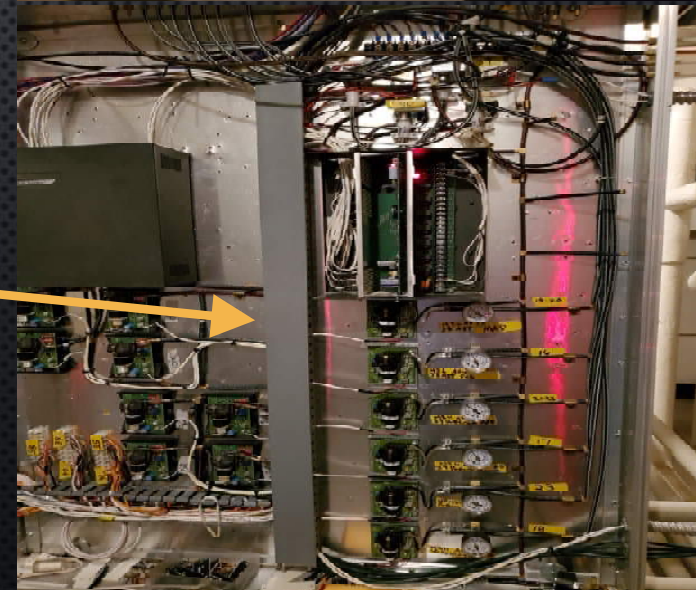
## MECHANICAL / PLUMBING

- ALL COMPONENTS OF THE HVAC SYSTEM HAVE EXCEEDED THEIR USEFUL LIVES
- THE HVAC CONTROL SYSTEM IS A MIX OF DIGITAL AND PNEUMATIC

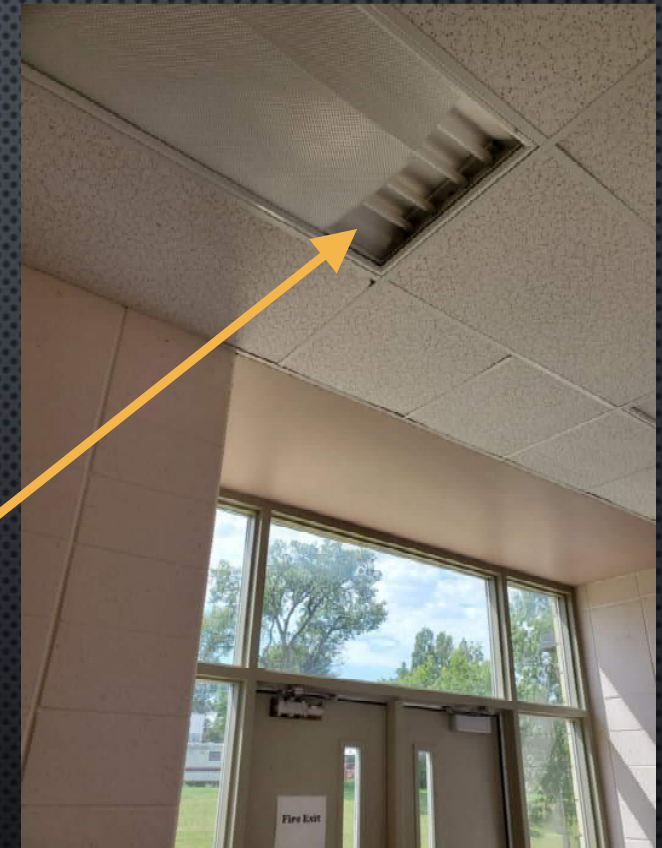
## ELECTRICAL

- LIGHT FIXTURES THROUGHOUT THE SCHOOL ARE T8 FLUORESCENT AND ARE ORIGINAL TO THE BUILDING

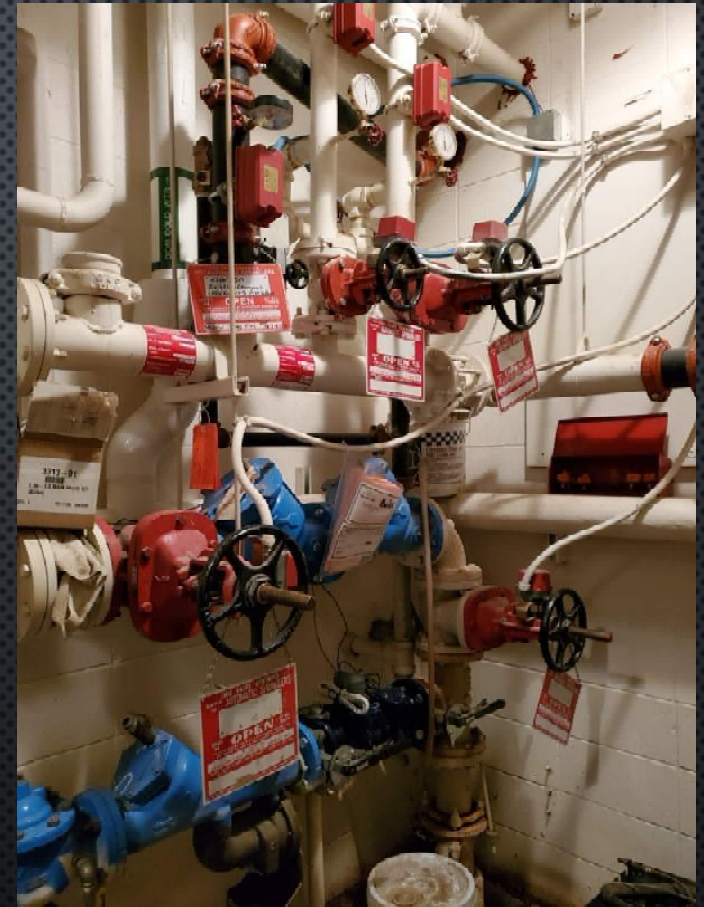
## LIFE SAFETY SYSTEMS

- BUILDING HAS PARTIAL SPRINKLER FIRE PROTECTION, MOST OF THE BUILDING IS UNPROTECTED

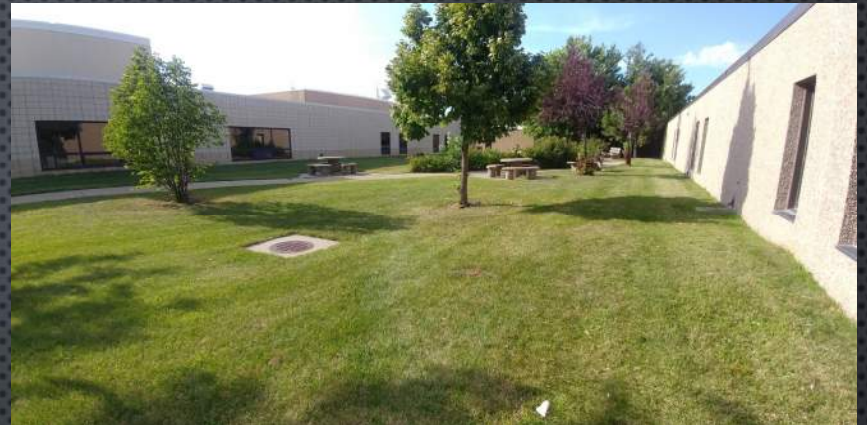
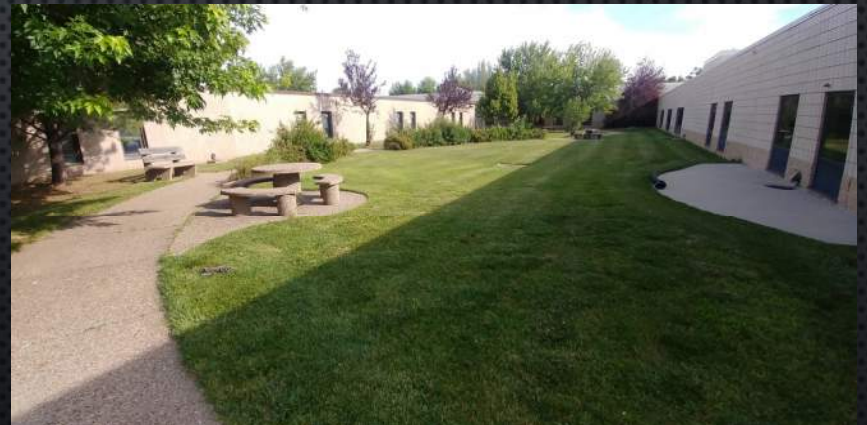
# SPEARFISH HIGH SCHOOL SITE

- THE CLASSROOMS ALONG THE COURTYARD SUFFER FROM WATER INTRUSION
  - THE DISTRICT HAS TRIED TO REMEDY THIS ISSUE OVER THE YEARS

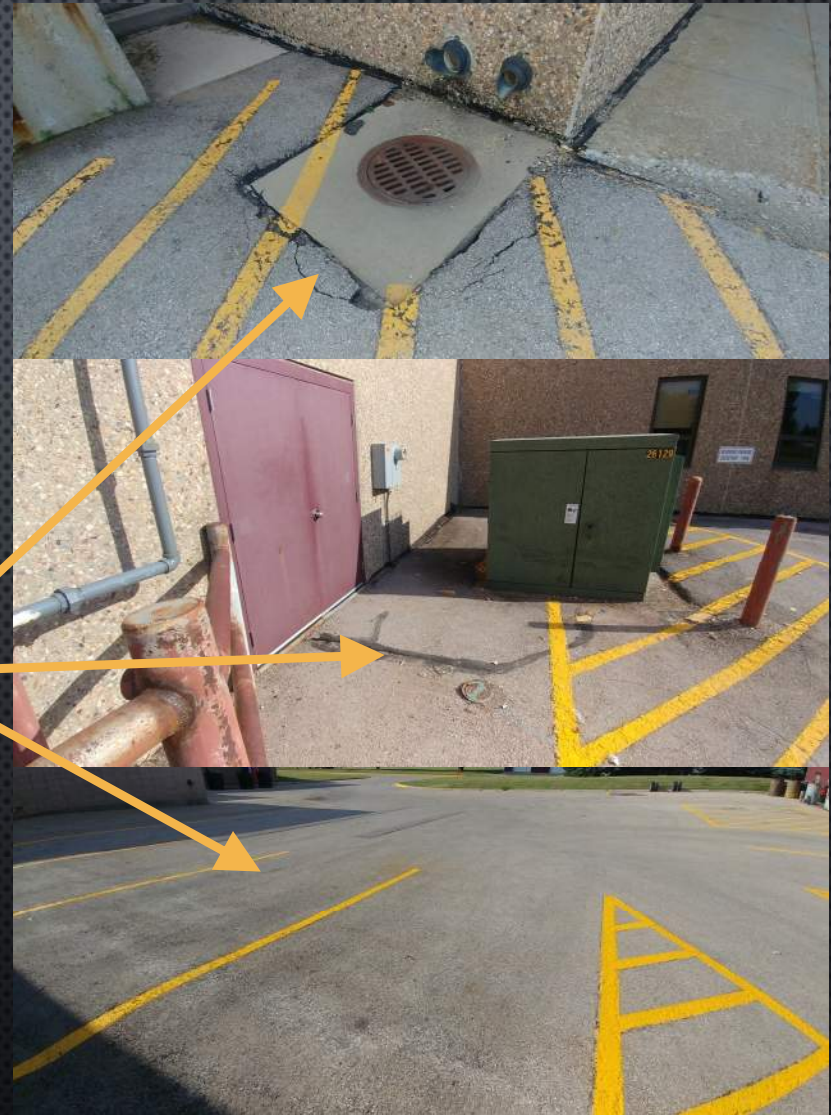
# SPEARFISH HIGH SCHOOL SITE

- THE STAFF PARKING LOT, ON THE NORTH OF THE BUILDING, IS BEGINNING TO SHOW HEAVY WEAR AND SLOPES TOWARD THE BUILDING

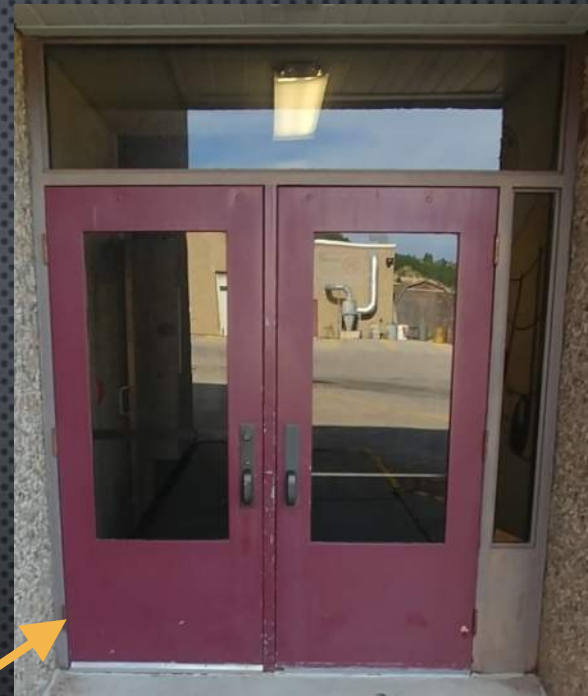
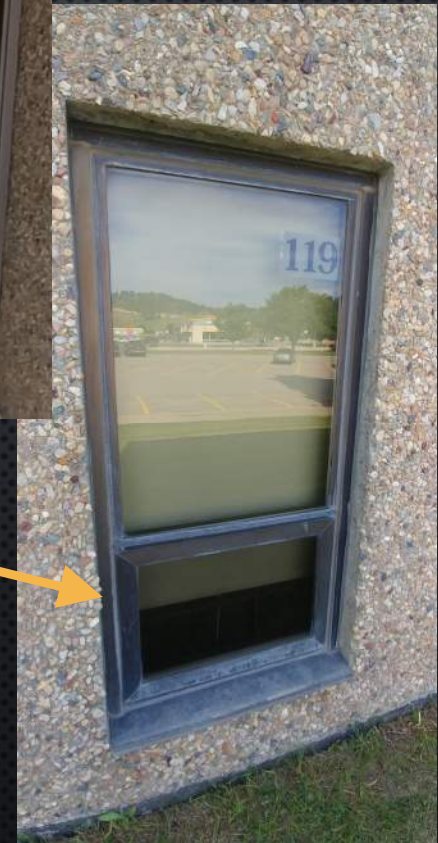
# SPEARFISH HIGH SCHOOL BUILDING ENVELOPE

- EXTERIOR DOORS,  
HARDWARE AND WINDOWS  
ARE DAMAGED AND  
BEYOND THEIR USEFUL LIFE

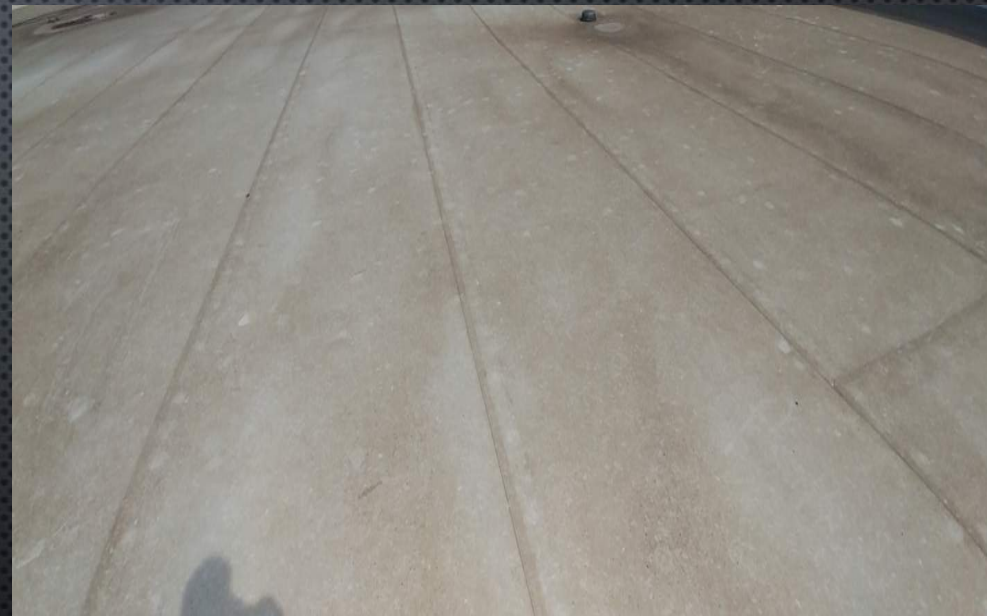
## BUILDING ENVELOPE

- THE HIGH SCHOOL ROOFING CONSISTS OF PVC. SEVERAL SECTIONS HAVE BEEN UPDATED IN 2010 AND 2015. THE REST IS EITHER PAST IT'S USEFUL LIFE OR WILL BE NEARING IT
