# District 40-2 Spearfish Schools

## Facilities Assessment

October 2019

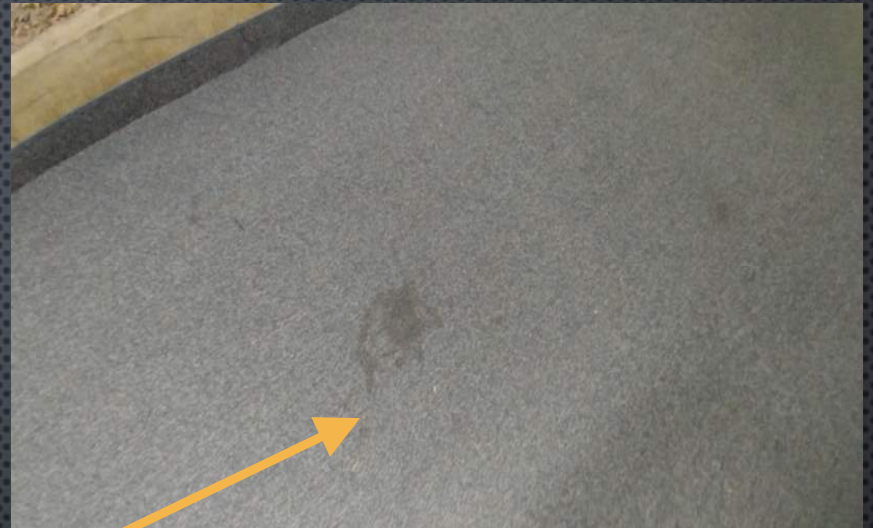
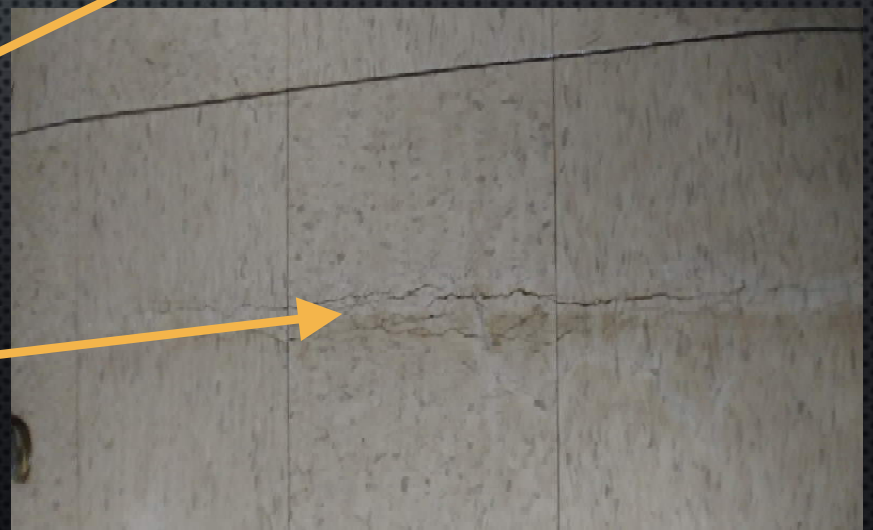
### INTERIOR FINISHES / BUILDING HARDWARE & EQUIPMENT

- FLOOR COVERINGS IN MANY AREAS ARE IN NEED OF REPLACEMENT
  - CARPET
  - VCT

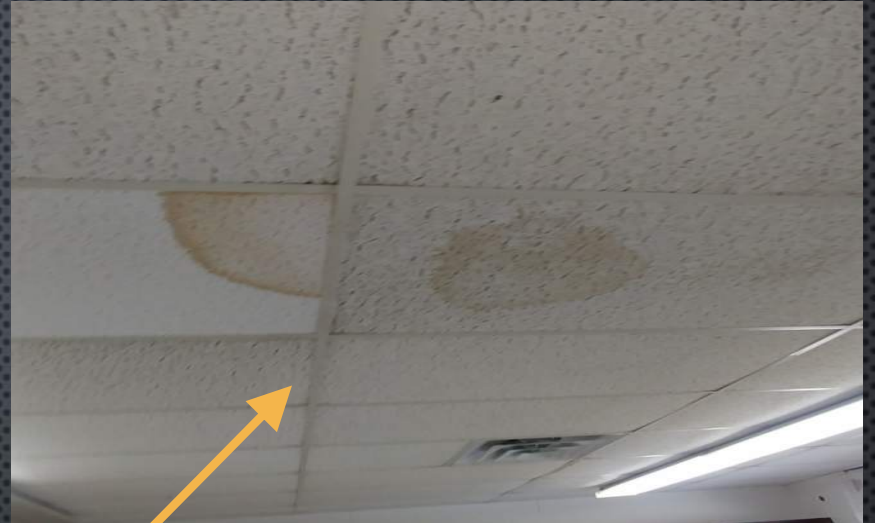
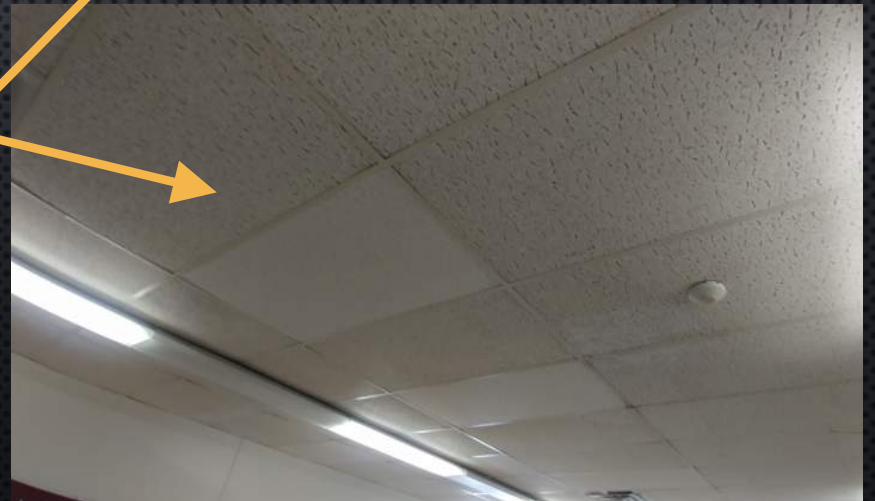
### INTERIOR FINISHES / BUILDING HARDWARE & EQUIPMENT

- THE OLDER SECTIONS OF THE BUILDING HAVE DAMAGED AND SAGGING ACOUSTICAL CEILING TILE (ACT)

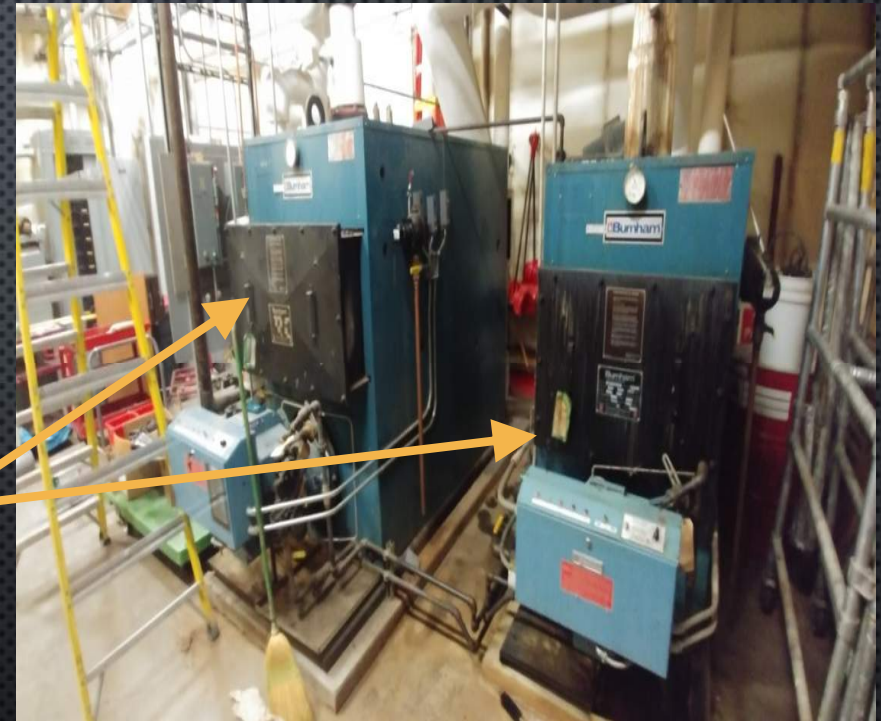
# SPEARFISH HIGH SCHOOL MECHANICAL / PLUMBING

- THERE ARE TWO BURNHAM HOT WATER BOILERS NEARING THE END OF THERE USEFUL LIVES AND REPLACEMENT IS NEEDED

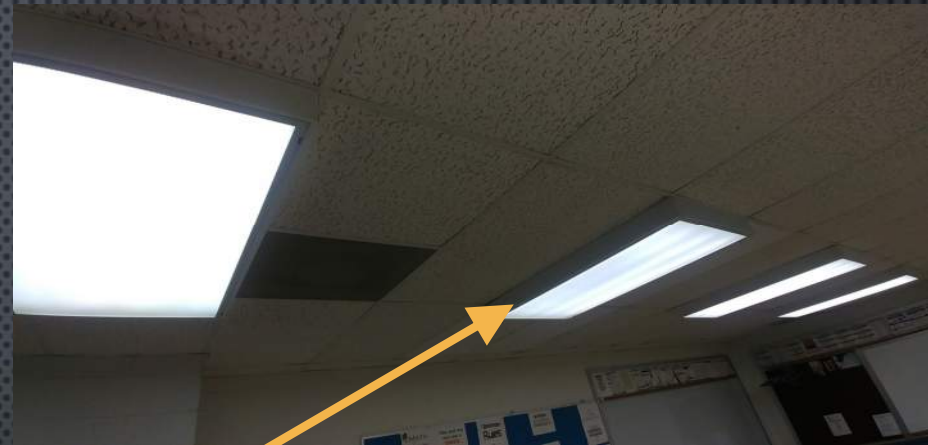
# SPEARFISH HIGH SCHOOL ELECTRICAL

- BUILDING LIGHTING

- THE INTERIOR CONSISTS OF T8 FLUORESCENT
- THE EXTERIOR IS HIGH INTENSITY DISCHARGE (HID)

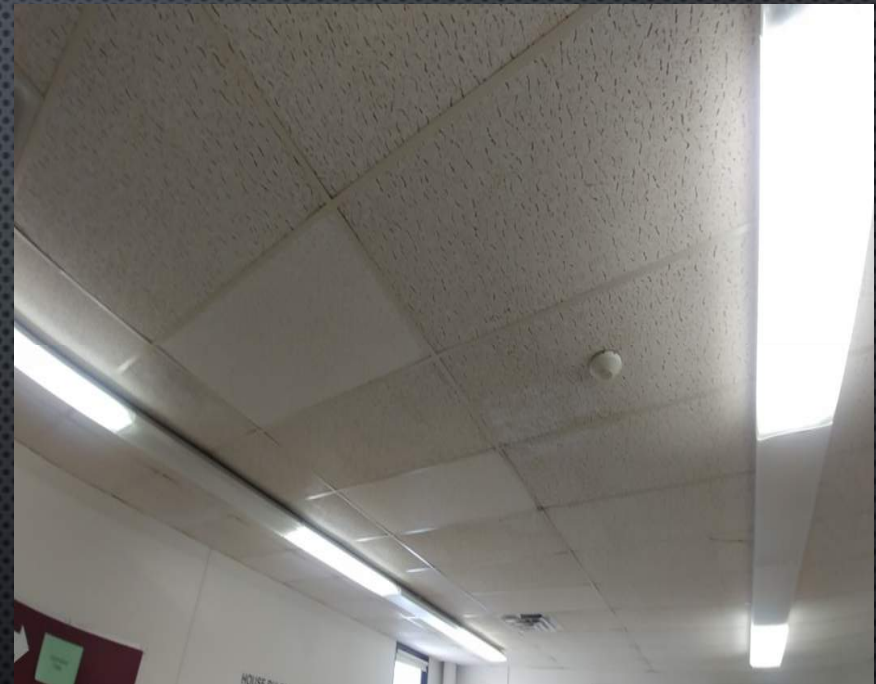
## LIFE SAFETY SYSTEMS

- THERE IS NO FIRE SUPPRESSION SYSTEM IN THE OLDER SECTIONS OF THE BUILDING

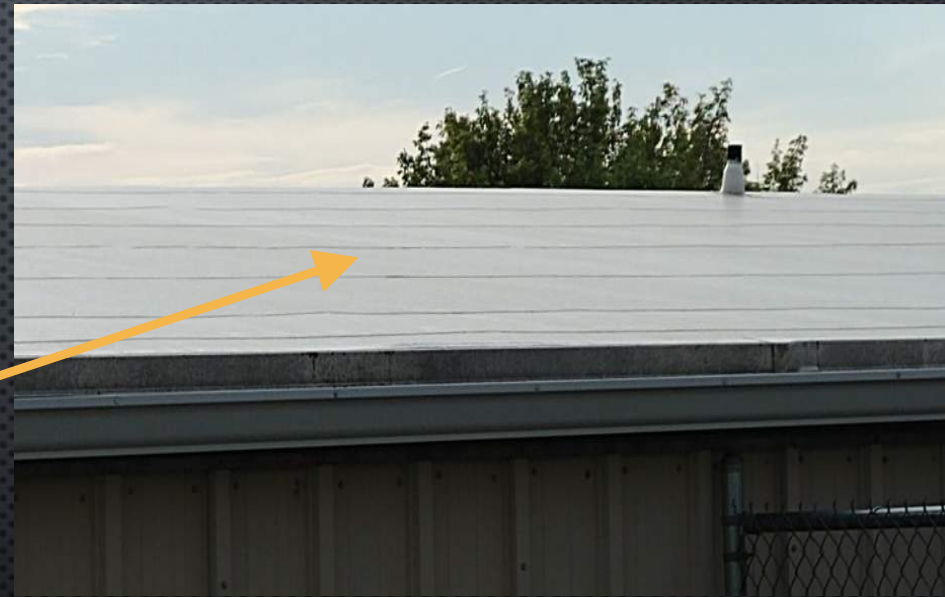
### BUILDING ENVELOPE

- IN 1998, THE ROOF WAS RETROFITTED WITH SINGLE PLY PVC AND INSULATION BETWEEN THE TIN ROOF GROOVES. THIS ROOFING TYPE USUALLY HAS A USEFUL LIFE OF 20-25 YEARS.

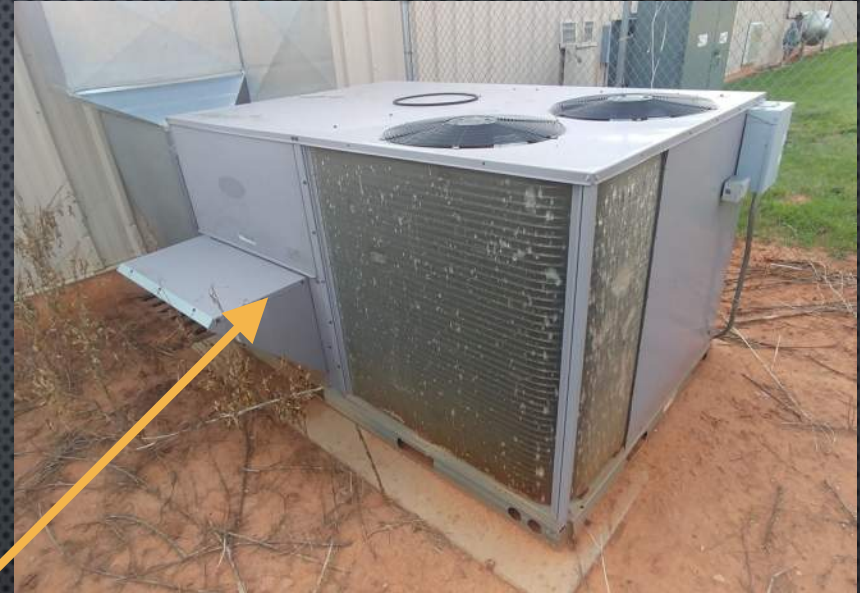
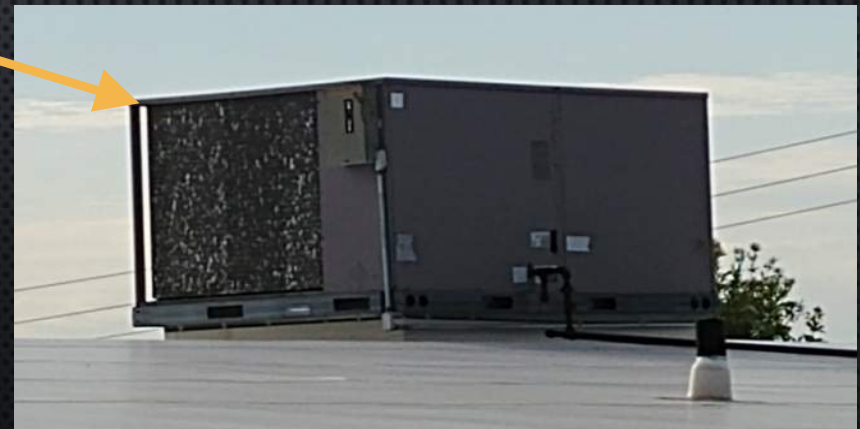
## MECHANICAL / PLUMBING

- THE GROUND AND ROOF TOP UNITS FOR THE BUILDING ARE 20+ YEARS OLD AND IN NEED OF REPLACEMENT.

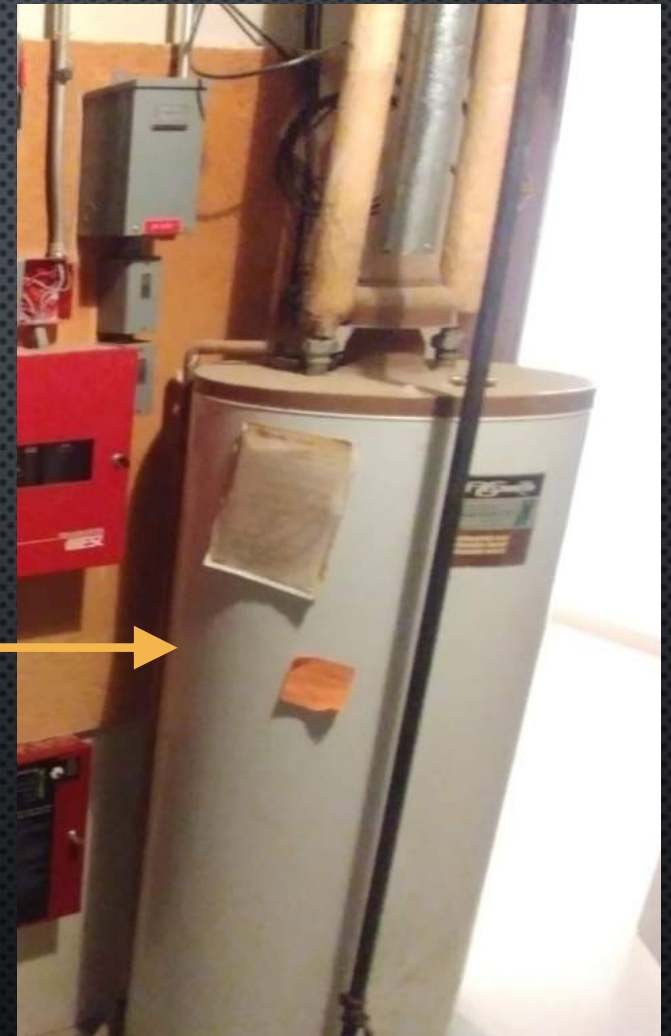
## MECHANICAL / PLUMBING

- THE DOMESTIC WATER HEATER IS 20+ YEARS OLD AND IN NEED OF REPLACEMENT.
