# District 40-2 Spearfish Schools

## Facilities Assessment

October 2019

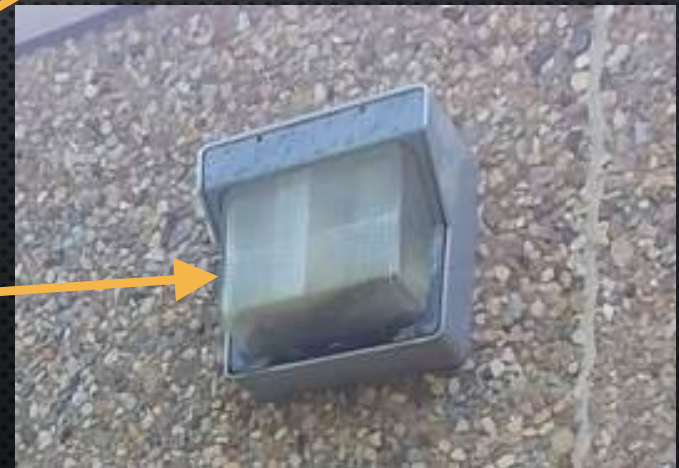
- THE INTERIOR CONSISTS OF T8 FLUORESCENT
- THE EXTERIOR IS HIGH INTENSITY DISCHARGE (HID)
